Kansas Department of Health and Environment

Voluntary Cleanup and Property Redevelopment Program

Cash Grain & Feed, Grimaldi Property

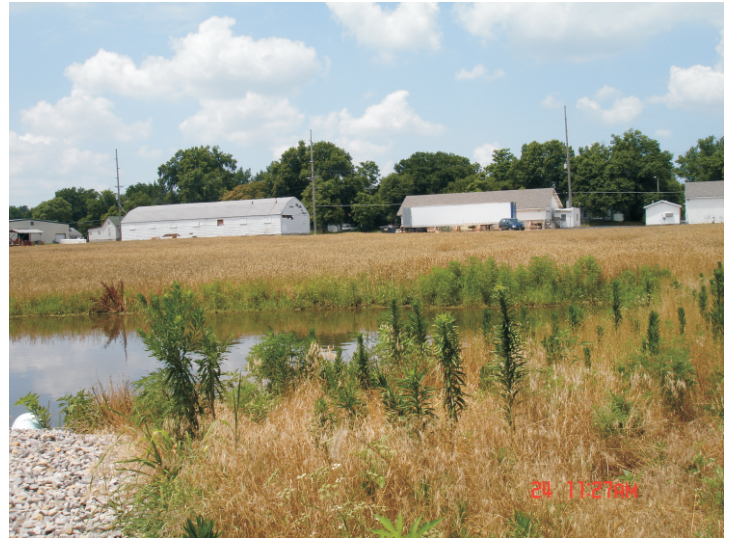
Stormwater retention pond and vegetative cover.

The cleanup action included consolidating highly impacted soils into an onsite burial area and covering it with a 4-inch impermeable asphalt cap, constructing a retention pond for storm water runoff, backfilling excavated and/or low-lying areas with approximately 450 cubic yards of clean fill soil, grading the site, seeding vegetated areas with a mixture of fescue and wheat, and implementing environmental use controls (EUCs) that (a) assure maintenance of the asphalt cap and vegetative cover and (b) limit exposure to possible lead contamination by restricting land use to non-residential purposes. Earth and seeding work was conducted in Fall 2008, the asphalt cap was constructed in June 2009, and EUCs were implemented in August 2009. The Southeast Kansas Recycling Center plans to acquire the property and use the buildings and land to support an expansion in recycling operations.

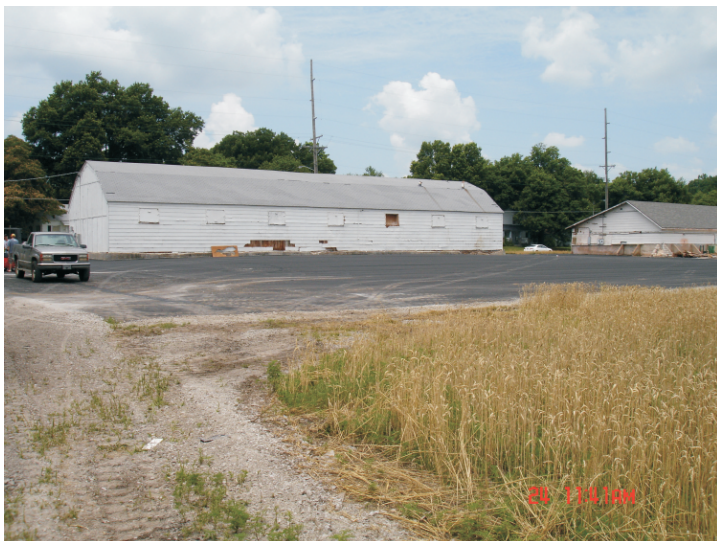
Asphalt cap covering consolidated material.
